Asia Pacific Coatings Congress

The Increasing Effect of UV / IR on Grey Roof Coatings

Philip Green- September 5th 2019

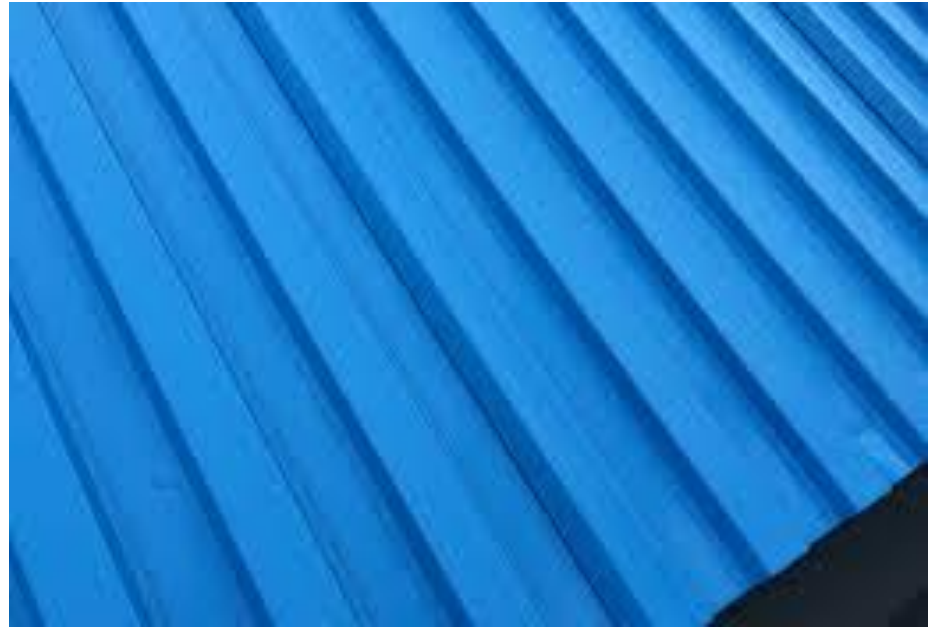
- Then in the early 1990's some of the larger paint companies started offering roof paints in deep/ bright colours like Royal Blue and Bright Green and due to the High UV in Southern Africa these Colours Faded/ Chalked quite quickly (2-3 Years) and eventually they were withdrawn much to most paint chemist's relief.

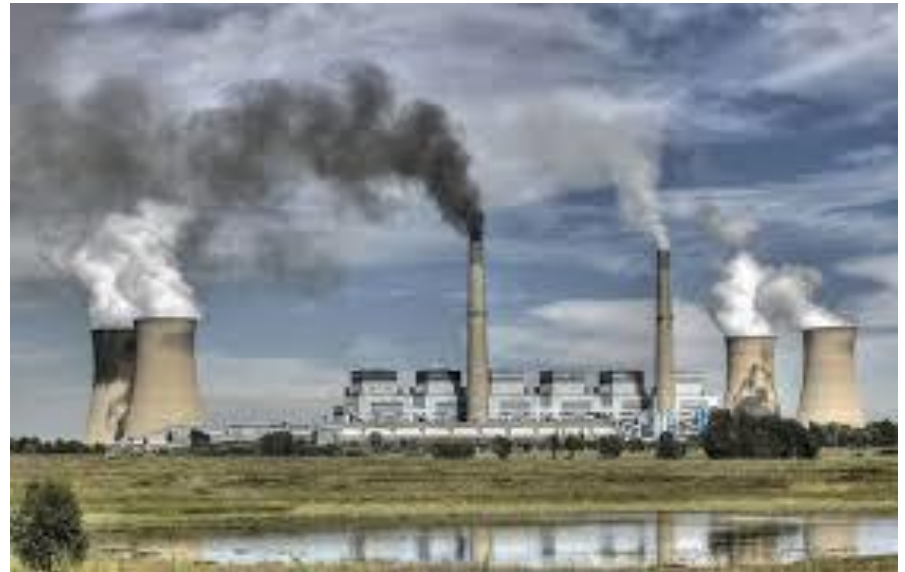
- Then in mid-late 1990's we started to see a range of oxide based earth colours (Red Oxide, Burgundy, Chrome Oxide Green and Greys) become lighter in colour within 6-12 months but not in all areas but in specific locations, it was also not limited to one companies roof coatings but more to Location.

- My consultancy was involved in thoroughly investigating the issue and after a lot of work we traced the cause to acidic rain coming from 3 sources:
 - Coal fired power stations
 - Oil refineries/ other industries
 - Burning off of crops at the end of the growing season
- All give rise to acidic air borne pollution that gets carried by wind and rain and then the acids attack the calcium carbonate in the roof coating causing the lightening effect

- We then investigated which extenders / combination of extenders could be used as a cost and property effective way to minimize the effects of acid rain in roof coatings, without affecting long term durability
- In RSA this was generally a Feldspar or Feldspar in combination with Talc or Mica but in other countries Baraytes and Kaolin were also used

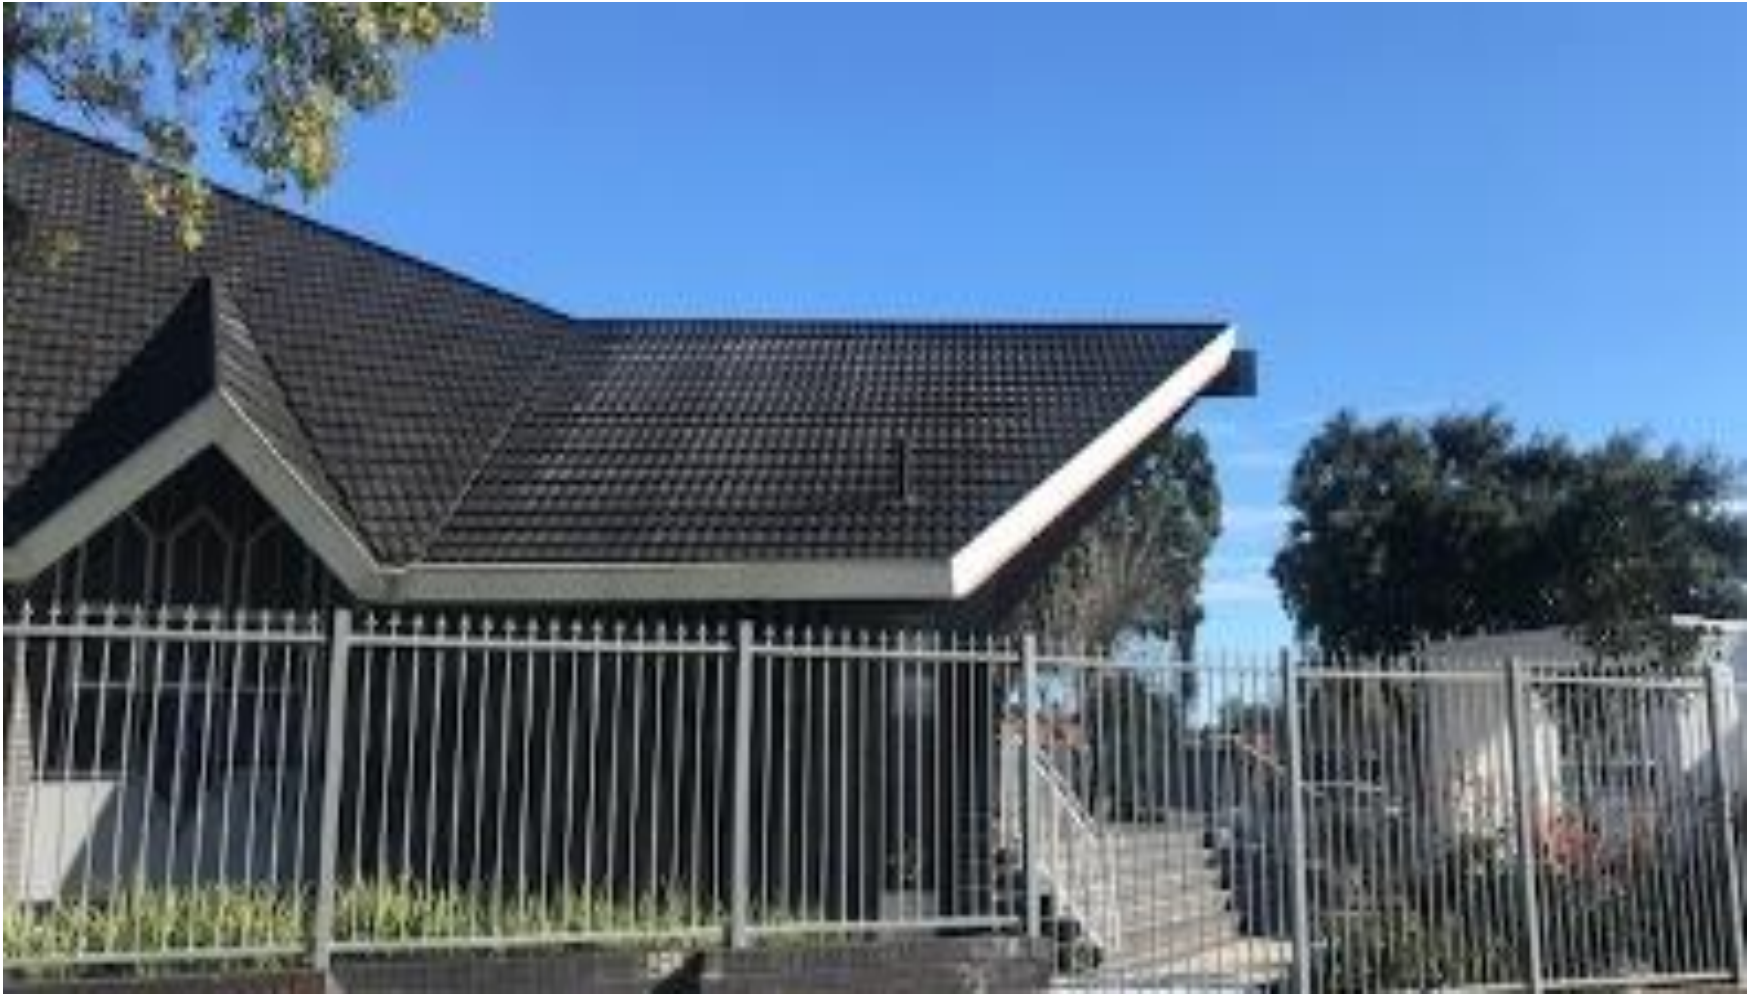
Example 1

- In 2015- 2016 we started to hear of roof coatings that started to prematurely fail and not just on site applied roofs but also factory applied water based roof tile coatings
- Again the problems were not limited to one paint producer or region but were from many producers and on analyzing the data there was only one common factor- they were all greys- with medium and dark greys showing the most issues
- For one company grey/ charcoal/ black roof coatings were 15-20% of their roof coating sales and 80% of their claims

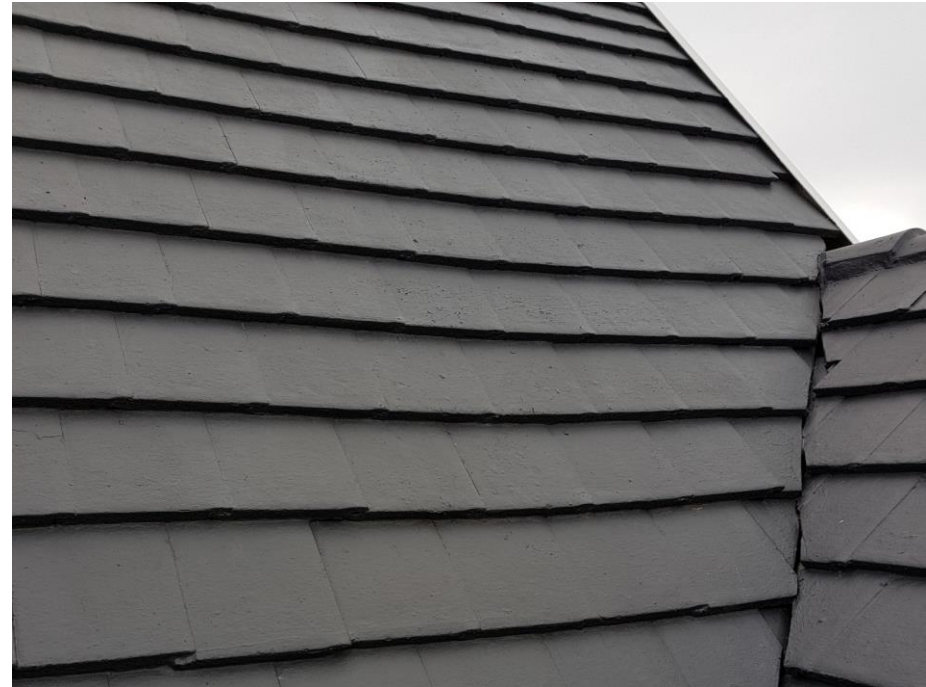
On Completion

After 18months
