Asia Pacific Coatings Congress

The Increasing Effect of UV / IR on Grey Roof Coatings

Philip Green- September 5th 2019

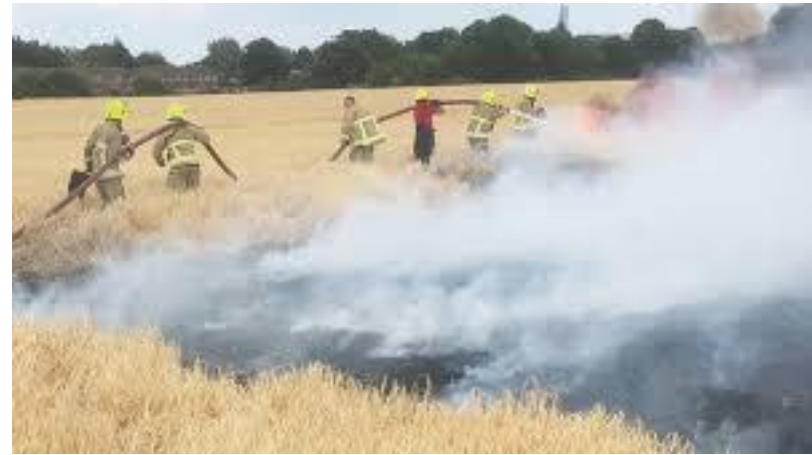
Acid Rain 2

- My consultancy was involved in thoroughly investigating the issue and after a lot of work we traced the cause to acidic rain coming from 3 sources:
 - Coal fired power stations
 - Oil refineries/ other industries
 - Burning off of crops at the end of the growing season
- All give rise to acidic air borne pollution that gets carried by wind and rain and then the acids attack the calcium carbonate in the roof coating causing the lightening effect

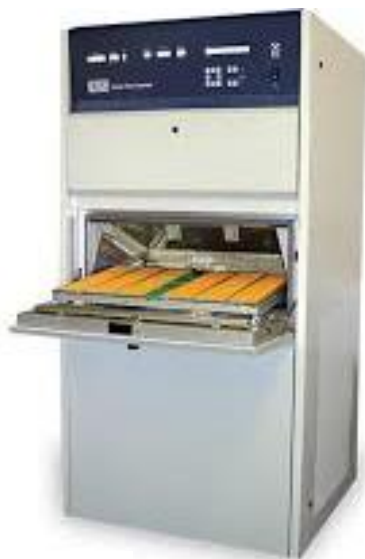
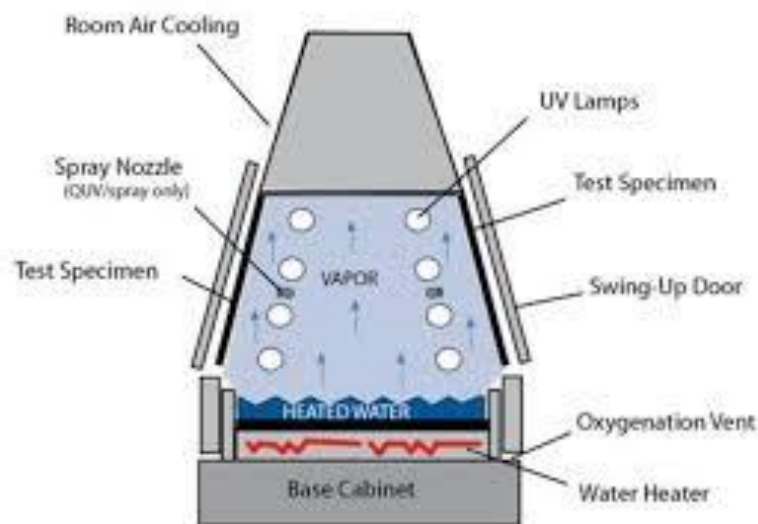
The UV Angle 3

- We then applied wet paint samples from many of the problem sites, on to panels and put them on exposure in a QUV and/ or a Xenon Accelerated Weather Chamber even after 2000 hours of exposure in the Xenon/ QUV we could not reproduce what we were seeing in the field

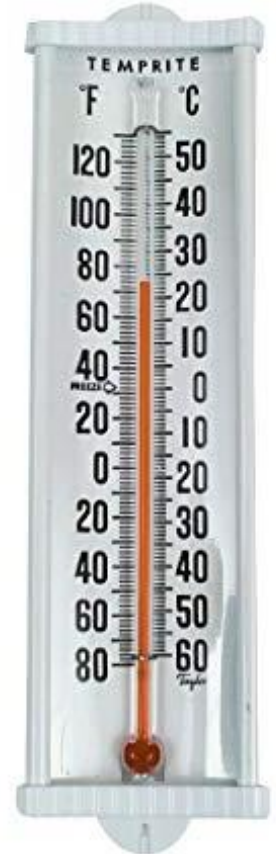
The UV Angle 4

- Someone suggested that the normal temperature (50-60°C) used in an accelerated weathering chamber (QUV or Xenon) was not quite high enough to reproduce the temperatures experienced on a roof so we set the black plate metal temperature to 80°C and ran the QUV cabinet for 1 000 hours again we could not reproduce the problem but we burnt out the sensor- so we abandoned that avenue

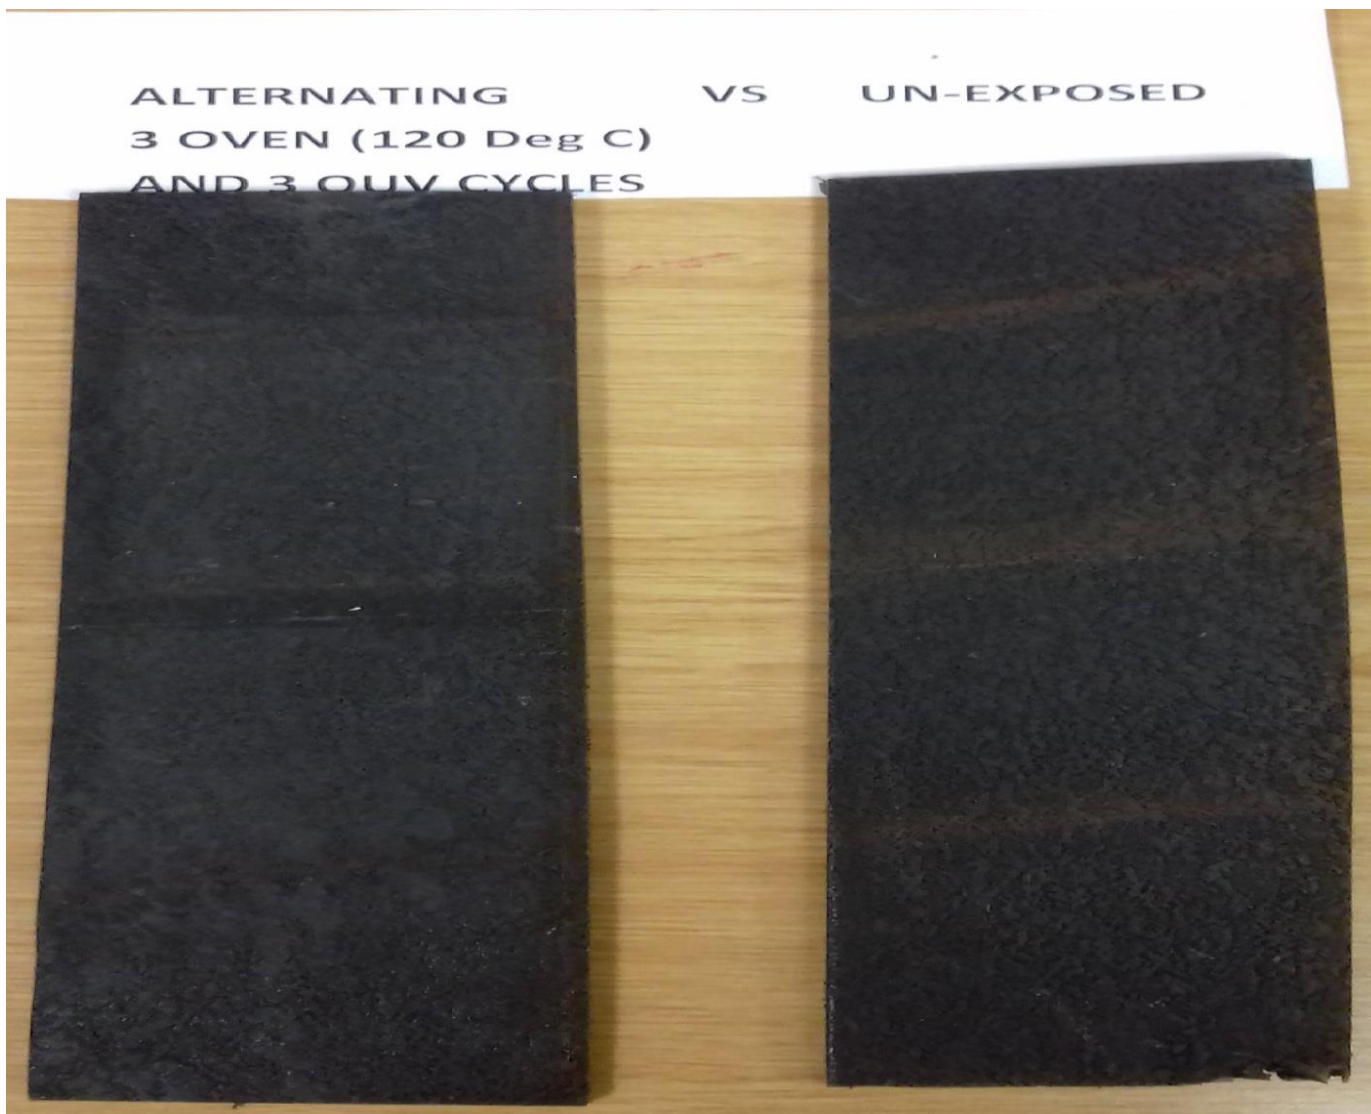
UV / IR Combined 2

- We then started to look at cycling between heat and QUV- we started with 4 days in an oven at 120°C and 3 days in the QUV- normal cycle.
- Then we started to reproduce what we had seen in the field mostly after 5- 6 cycles or longer but for some polymers that had not shown any issues in the QUV / Xenon started to show issues after only 2-3 cycles

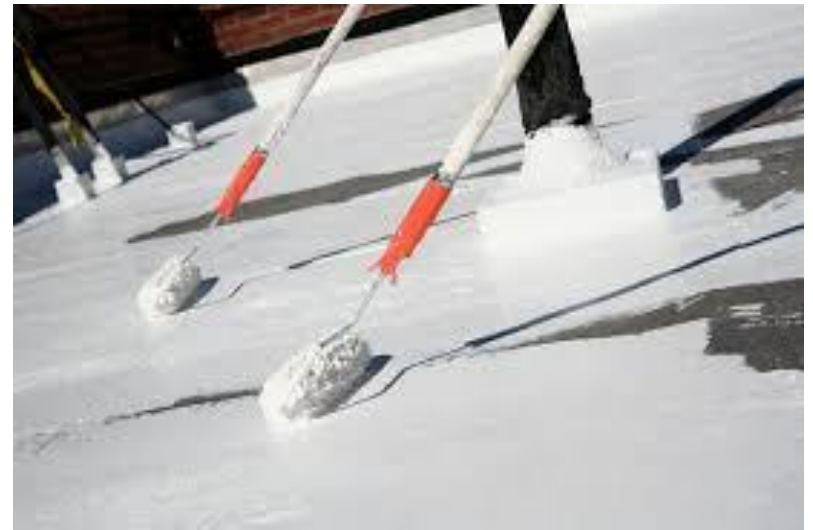
UV / IR Combined 7

- We are also seeing that both film build and on re-painting roofs what the original colour on the roof was- if it was black / dark grey it has to be isolated from the new top IR Reflective Black Pigment containing roof coat by coats of a white roof paint before repainting.
